# **NI 43-101 Technical Report San Carlos Property, Río Viejo, Norosí, and San Martín de Loba Municipalities, Bolívar, Colombia**

Report Prepared for

**8768820 Canada Inc.**

**Effective Date: June 30<sup>th</sup>, 2015**  
**Report Date: June 30<sup>th</sup>, 2015**

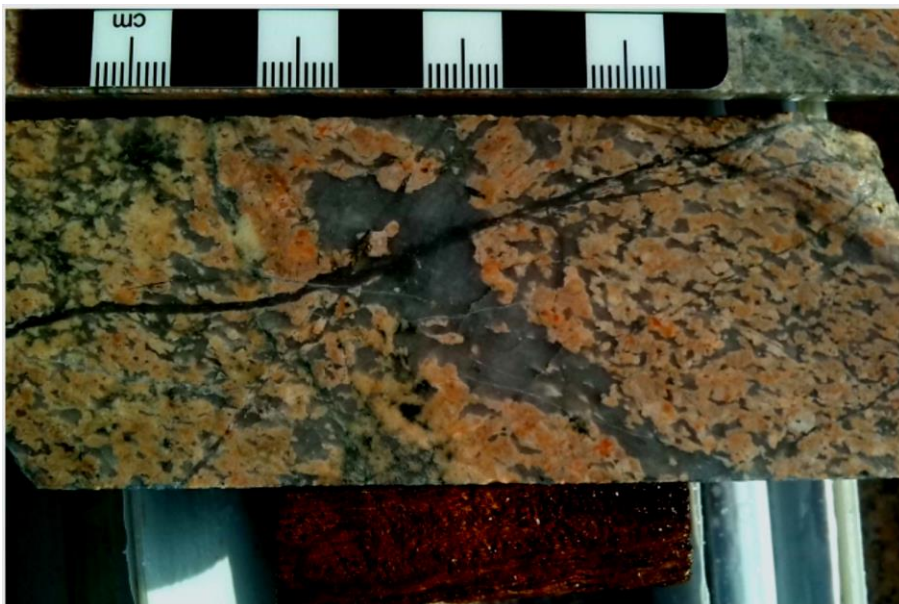
**Figure 7.3 Gneiss in Drill Hole SAC13DDH001, 550.50 m.**

The distribution of the Mezoproterozoic Gneiss occurs covering most of the north zone of the area study and in isolated hills that stand in your own flat relief to the south zone of the Property, **Figure 7.4**. The gneiss consists of thin continuous and undeformed strips up to 5 cm thick, composed by quartz, feldspar, plagioclase, biotite, amphibole and iron oxides. The banding is defined by white bands composed of quartz and plagioclase sodium and dark bands composed of amphibole (hornblende), mica (biotite) and iron oxides. **Figure 7.3** shows core of gneiss in San Carlos hill.

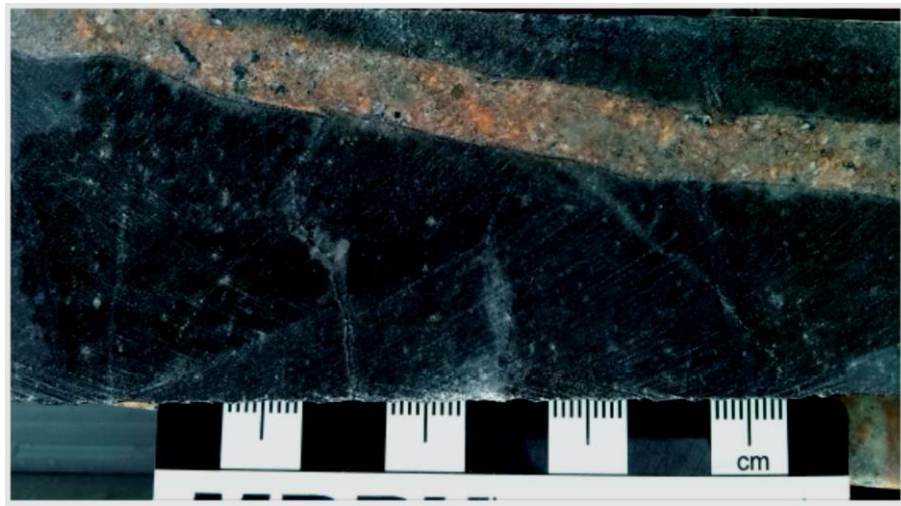
**Figure 7.5 Andesitic Tuff, Cut by Quartz-Monzonite-Diorite Porphyritic Micro-Dike.  
Drill Hole SAC13DDH002, 621.10 m.**

The basal part of the known volcanic sequence is formed by lava and lithic tuffs of andesitic composition of dark green to grey color, locally magnetic, hard and compact. The mineralization is apparently not favorable in this unit. The alteration is weak chlorite and the veining intensity is much lower than in the rhyolitic levels. This unit is observed at depth in the drill holes completed in San Carlos Hill, **Figure 7.5**.

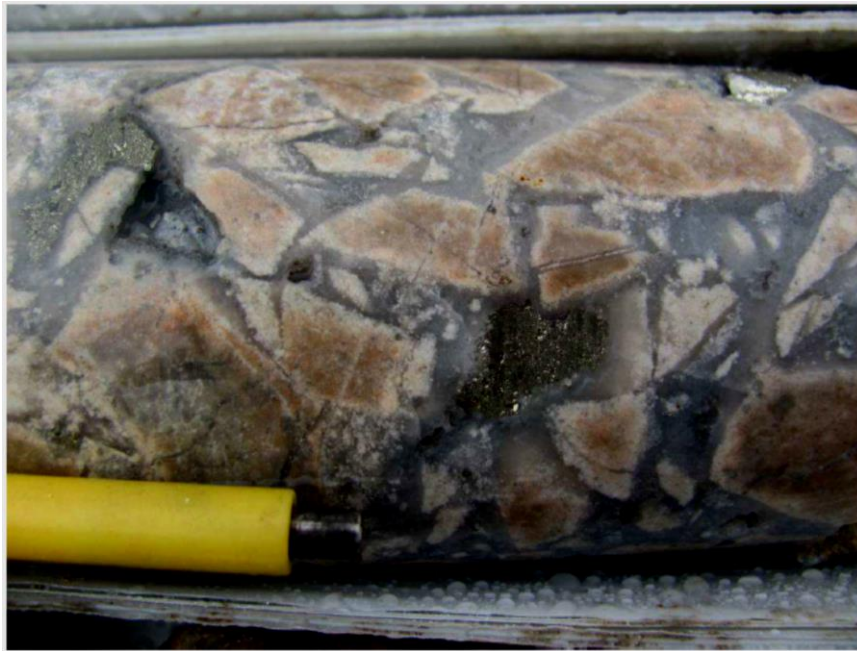
**Figure 7.8 Hydrothermal Breccia with Crypto - crystalline Quartz in Drill Hole SAC13DDH001, 351 m Depth.**

Possibly of Jurassic age, the breccias consist of quartz matrix and angular to sub-angular fragments of granodioritic and granitic intramineral porphyries. It also includes magmatic breccias with matrix of granodioritic porphyry and subangular clasts of sub-angular granitic and granodioritic porphyries. (Anglo American, 2013). **Figure 7.8** shows core of hydrothermal breccia of San Carlos Hill.

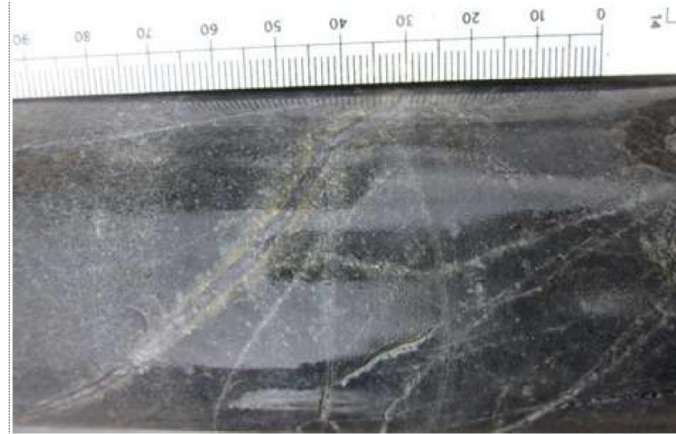
**Figure 7.17 Andesitic Tuff with Potassic – Calcic Alteration.**

*Potassic -Calcic Alteration:* At 268 m depth in drill hole SAC13DDH\_001 are observed the andesitic tuffs with moderate to strong alteration with disseminated secondary biotite, with veinlets of secondary biotite inter - grown with epidote, AB - type veinlets of quartz with suture of molybdenum  $\pm$  chalcopyrite and halo of K feldspar – epidote – chalcopyrite toward the borders of the K feldspar – biotite alteration, **Figure 7.17**, (Anglo American, 2014).

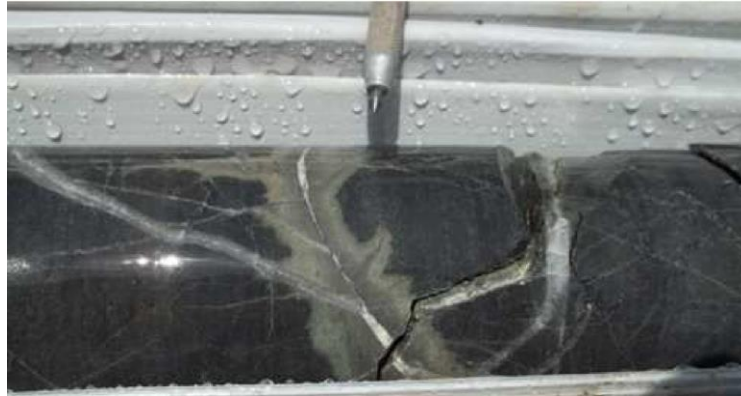
**Figure 7.19 Andesitic Tuff with K Feldspar – Sodic Alteration Overprinting the Moderate Secondary Biotite Alteration in Drill Hole SAC13DDH001, 294 m Depth.**

*Albitic alteration.* This alteration is observed in the andesitic tuffs in drill holes SAC13DDH001 and SAC13DDH002 where the association of moderate potassic – calcic alteration in EB - type veinlets with pyrite – chalcopyrite with halo of K feldspar – albite  $\pm$  calcite is overprinting the moderate secondary biotite alteration in the andesitic tuffs. This alteration is commonly observed in the borders of the K feldspar alteration, **Figure 7.19**, (Anglo American, 2014).

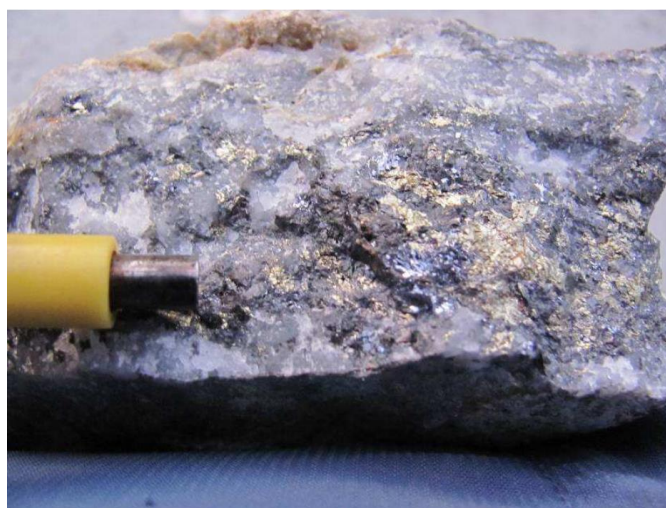
**Figure 7.24 Mineralization in El Azul. Milky Quartz – Pyrite – Chalcopyrite – Galena - Sphalerite.**

The mineralization of high grade gold veins in El Azul is hosted by gneisses and is characterized by the association quartz (chalcedonic) – pyrite – chalcopyrite – sphalerite - galena (**Figure 7.24**). The hydrothermal alteration of illite - sericite is present in halos of few centimeters and passing quickly to chlorite - epidote  $\pm$  pyrite moving away from the veins. The veins have a longitudinal mineral zonation from the periphery with quartz, then quartz - pyrite, then quartz – pyrite - chalcopyrite and in the inner part of the veins with quartz – galena - sphalerite (mamatite) – chalcopyrite - pyrite. Locally some veins contain calcite and rhodochrosite (Mera-Carvajal, 2013).

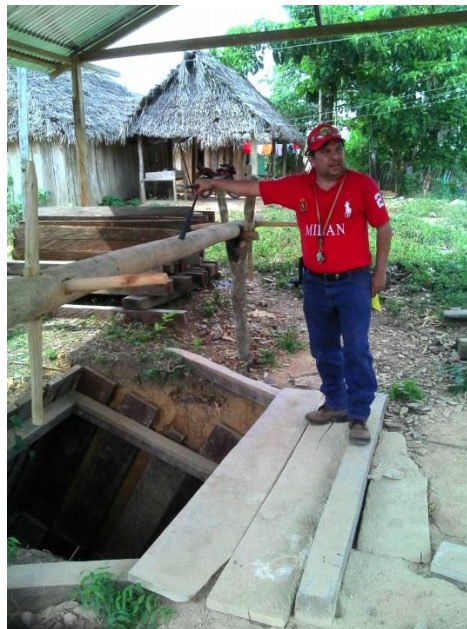
Figure 7.26 Inclined Access of the Luis Florez Tunnel in El Azul.

At least 5 veins have been identified in El Azul (**Figure 7.25**). The strikes of the veins vary from N - S to N10E and the dip from 80 to 90°. The horizontal extension observed in the artisanal workings reach 800 m. Some veins crop out at surface and the exploited depth observed in the artisanal workings reach 80 m depth. The miners enter to the exploitation faces through vertical and inclined shafts. The **Figure 7.26** shows the inclined shaft in El Azul.

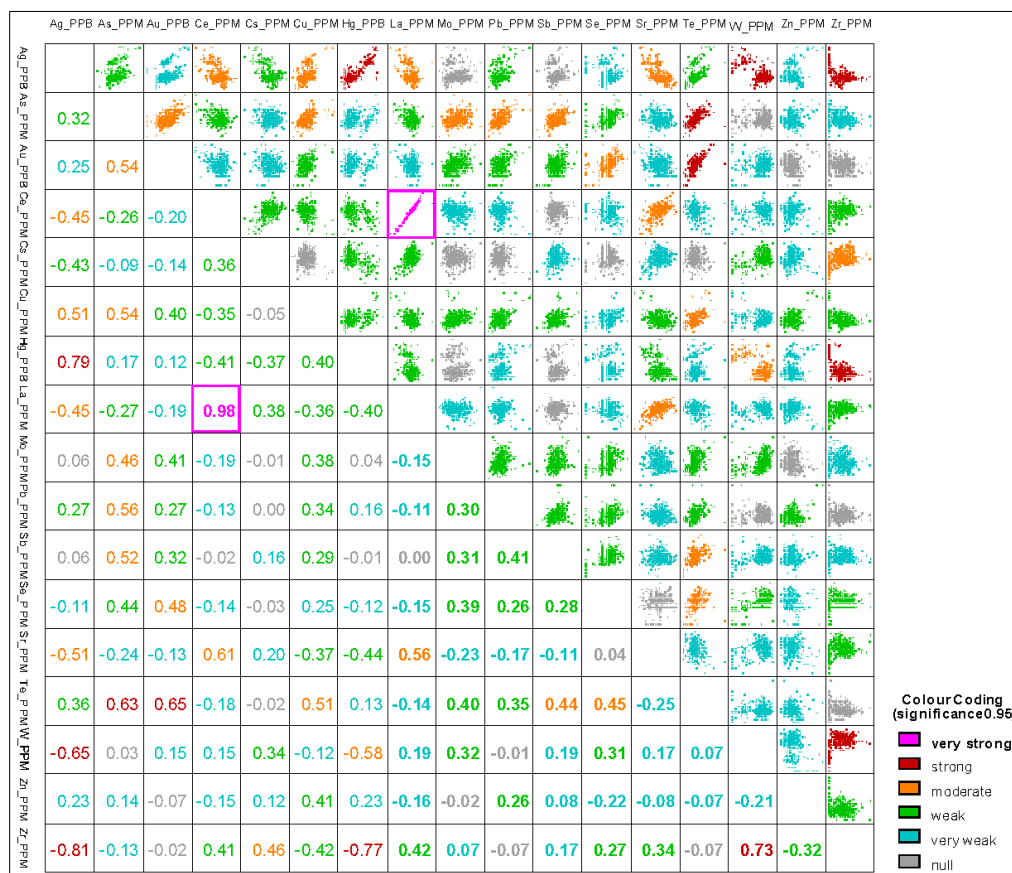
**Figure 9.4 Correlation Diagram for Rock Samples from El Azul.**

The results show positive correlations of Au with Te, Ag, Cu, Pb, Zn, Hg y Sb; and of Cu with Zn, Ag, As, Hg, Pb, Au, Mo y Se; which is concordant with the mineralization, **Figures 9.3 and 9.4** show the correlation diagrams constructed with the results of the rock samples from San Carlos Hill - Buena Señá - Culo Alzao area and El Azul (Mera & Carvajal, 2013).

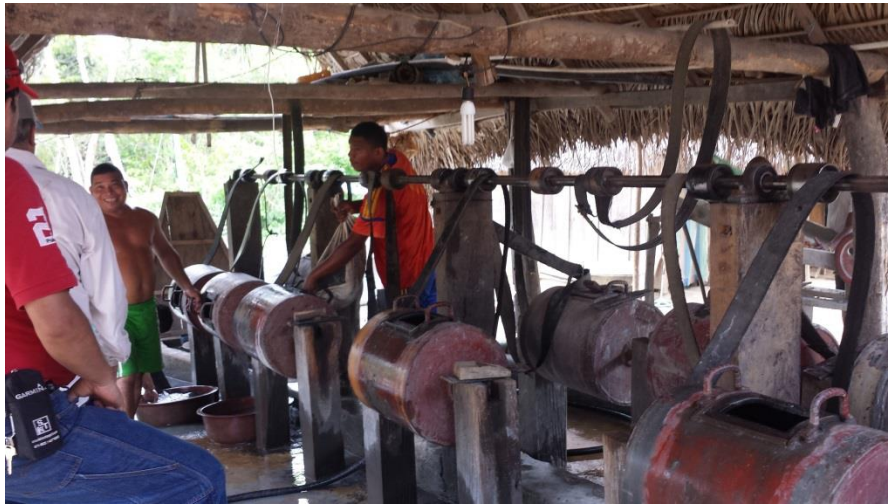
**Figure 20.1 Artisanal Process Plant in El Azul.**

In the areas of San Carlos Hill - Buena Seña, Culo Alzao and El Azul, there are many not authorized mining. These activities are being carried out by locals using artisanal methods of exploitation and processing (Use of mercury) without environmental, technical and safety controls, **Figures 20.1 and 20.2.**
